## Test Report

Report Number: 160329SHJ-AMQS

Product: Auto Radiator  
Model: RA-01  
Samples Quantity: 3 pieces  
Sample ID: N/A  
Date Received: Apr. 2<sup>nd</sup>, 2016  
Date Test Conducted: Apr. 4<sup>th</sup>, 2016 – Apr. 27<sup>th</sup>, 2016  
\*Trademark: N/A  
\*Rated capacity: N/A  
\*Size/color: Black frame  
Test address different from lab address (if existed) : N/A

Test protocol/standard: SASO 82/2008, SASO 83/2008      Test duration: Apr. 4<sup>th</sup>, 2016 – Apr. 27<sup>th</sup>, 2016  
SASO 2278/2011

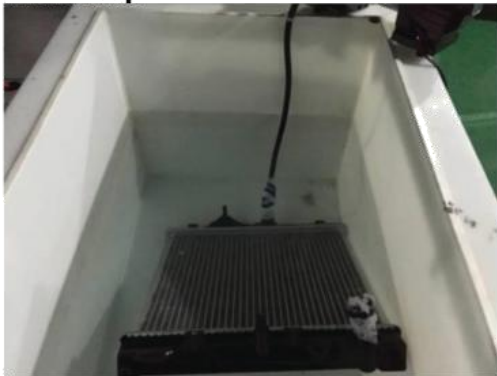
| TESTS PERFORMED | | | | |
|---|---|---|---|---|
| 2 | Leakage Test | <ul style="list-style-type: none"> <li>- The water outlet pipe and the upper and lower tanks shall be tightly sealed and the pressure cap replaced by a normal close fitting cap (without pressure valve).</li> <li>- The inlet water pipe shall be connected to an air supply source at a pressure of 150 kPa (about 1.5 kg/cm<sup>2</sup>).</li> <li>- The radiator shall be immersed in water and subjected to pressure for a period of not less than 30 seconds and any leakage observed.</li> </ul> (SASO 83/2008, section 6 requirements) | Major | Meet |
| <b>OBSERVATION:</b> No leakage was found during test.<br><br><b>Test setup</b><br> | | | | |

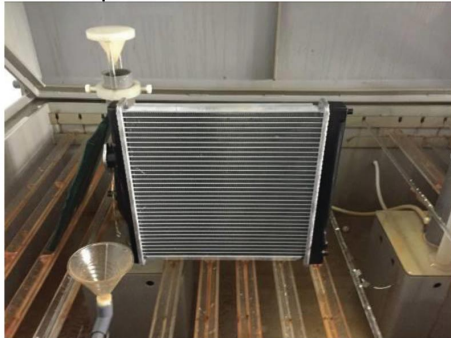
| TESTS PERFORMED | | | | |
|---|---|---|---|---|
| 3 | Corrosion Resistance Test | The radiator shall be exposed from both sides to a (5 ± 1%) (by weight) salt water spray for 4 days and allowed to stand for drying out in a room at a temperature of 23 ± 2°C and 60 ± 10% relative humidity, for 14 days. The radiator shall then be subjected to a hydraulic pressure of 100 kPa (nearly 1.0 kg/cm <sup>2</sup> ) and any leakage observed.<br>(SASO 83/2008, section 5 requirements) | Major | Meet |

| <p><b>OBSERVATION:</b><br/>Sample was tested following required procedures. No leakage was found.</p> <div> <div>Test setup</div> </div> <div> <div>After test</div> </div> <p><b>ACTION:</b> N/A</p> | | | | |

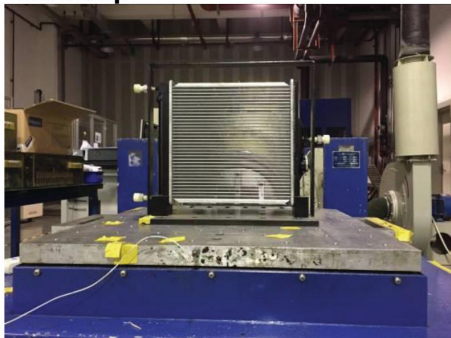
| 4 | Vibration Test | <p>The radiator shall be fixed as in normal use, and subjected to vibration up and down in the actual state of attachment to the vehicle at 3 G, and 3 mm span for one million times. It shall then be checked to ensure the soundness of all its parts.<br/>(SASO 83/2008, section 8 requirements)</p> | Major | Meet |
| <p><b>OBSERVATION:</b><br/>After the vibration test, no damage or looseness of parts were found.</p> <div> <div>Test setup</div> </div> <p><b>ACTION:</b> N/A</p> | | | | |

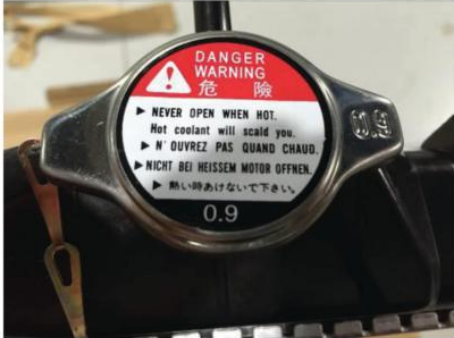
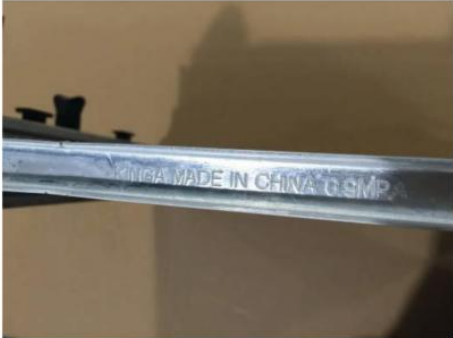
| <p><b>OBSERVATION:</b><br/>Required markings were found on sample.</p> | | | | |

| Requirement | Finding |
|---|---|
| Manufacturer's name, and/or his trade-mark | "KINGA" was marked on sample. |
| Country of origin | "Made in China" was marked on sample. |
| The pressure at which the cap valve opens | "0.9 MPA" was marked on sample. |
